OIL TANK DETECTION REPORT

Site address: 4635 Bond Street Burnaby

Survey date: July 24, 2018

GeoScan Project # J180912-04

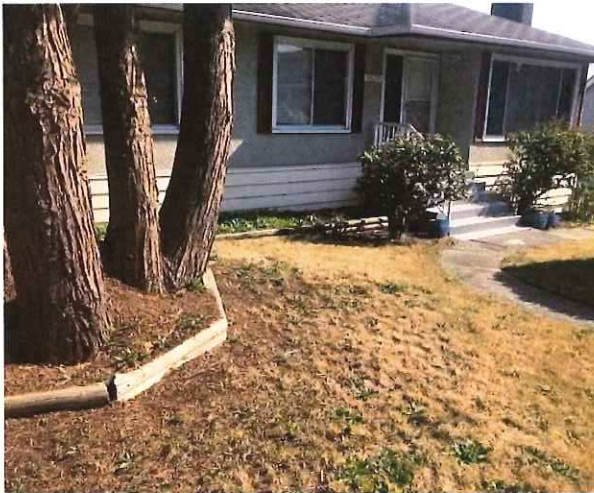
We were unable to scan under and within approximately 2 feet of the front southern concrete stairs and garden bed posts due to interference.

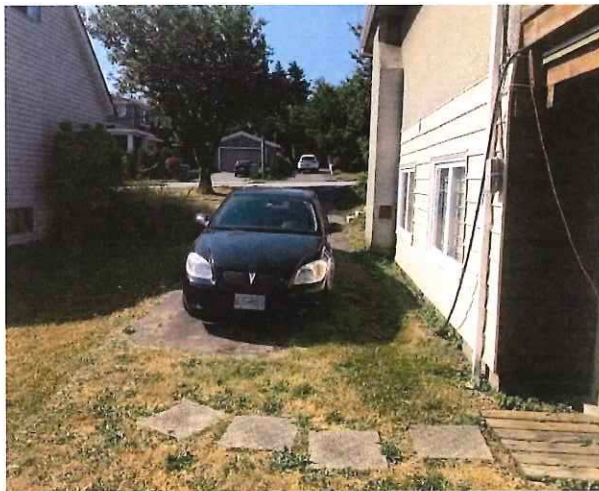
We were unable to scan under and within approximately 6 feet of the vehicle obstruction in the eastern driveway due to interference.

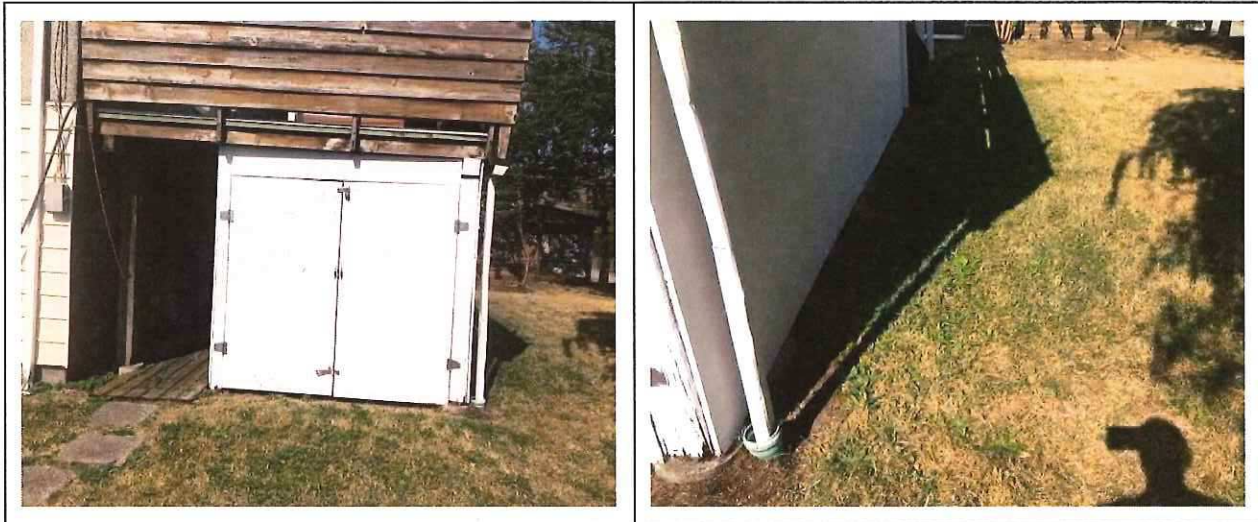
We were unable to scan under and within approximately 3 feet of the back north eastern storage area. Additionally we had an approximate 2 feet by 6 feet reading approximately 3 feet north of and running parallel with the storage area. This reading was closest to the north western side of the storage area. If the client would like to investigate these areas further we would recommend a GPR scan in these areas.

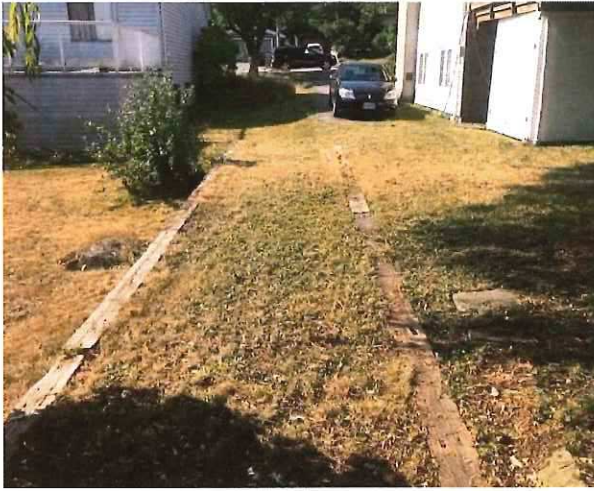
We were unable to scan under and within approximately 2 feet of the garden bed posts on the back north eastern corner due to interference.

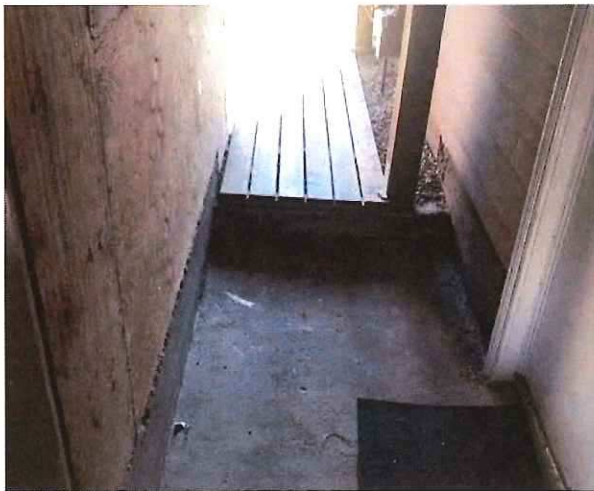
We were unable to scan under and within approximately 2 feet of the concrete sidewalk and wooden platform due to metallic interference and lack of clearance.

If the client would like to investigate the concrete area further we would recommend a GPR scan in this area.

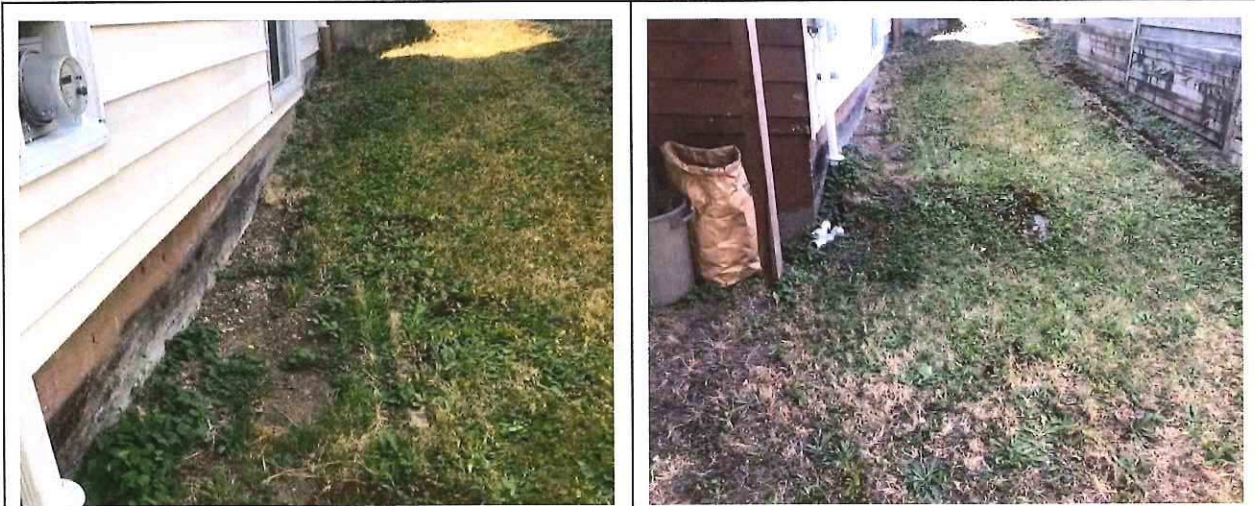
We were unable to thoroughly scan on the western side of the house mainly on the north half of the western side due to interference. Additionally, we had sporadic readings in the area closer to the north western corner approximately 2-4 feet north west and approx 1.5 feet by 5 feet in size. If the client would like to investigate these areas further we would recommend attempting a GPR scan in these areas.

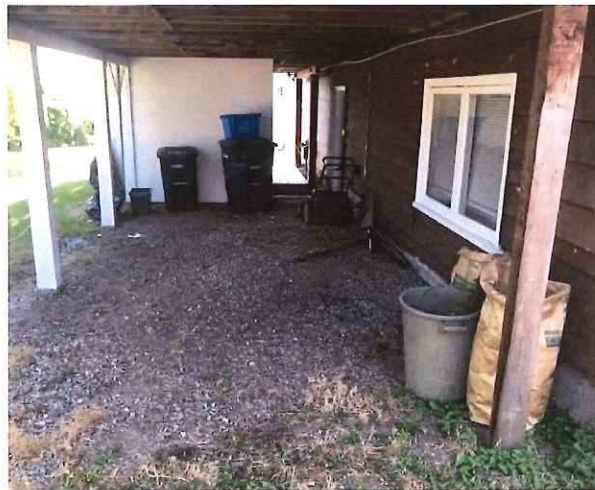
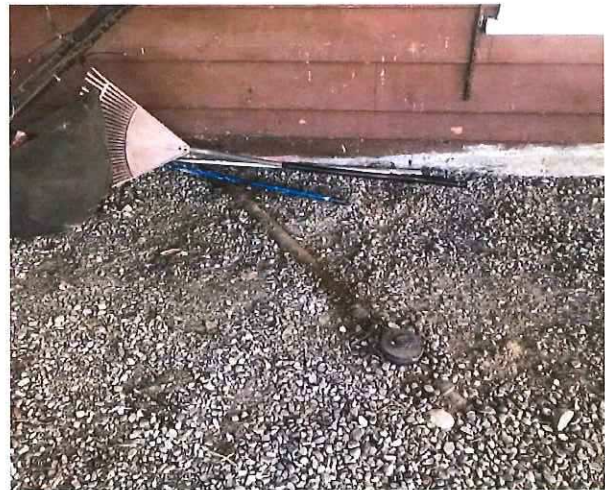
We were unable to scan under and within approximately 3 feet of the item obstructions on the northern side of the house on the western side due to interference. Additionally, we had readings and interference from the pipe that was present and causing interference throughout the area. If the client would like to investigate these areas further we would recommend a GPR scan in these areas.

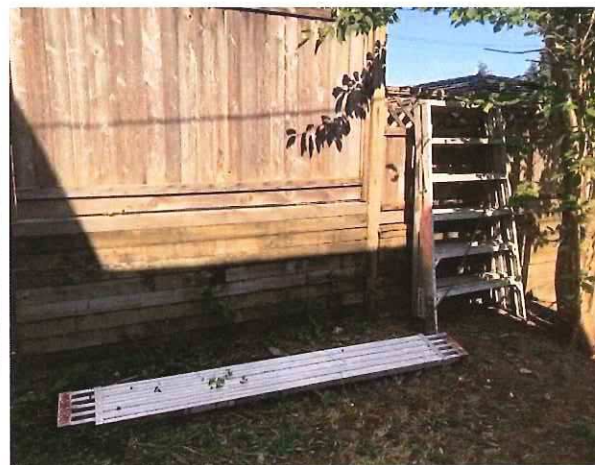
We were unable to scan under and within approximately 3 feet of the item obstructions on the north western side of the yard due to interference.

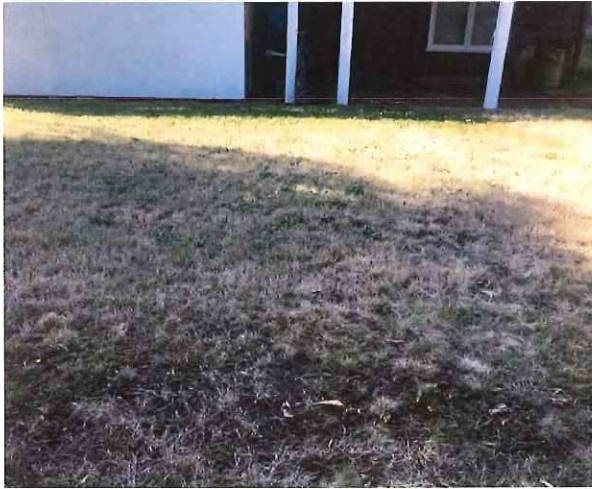
We had a small reading in the northern yard approximately 1 x 2 feet.

If the client would like to investigate this area further we would recommend a GPR scan in this area.

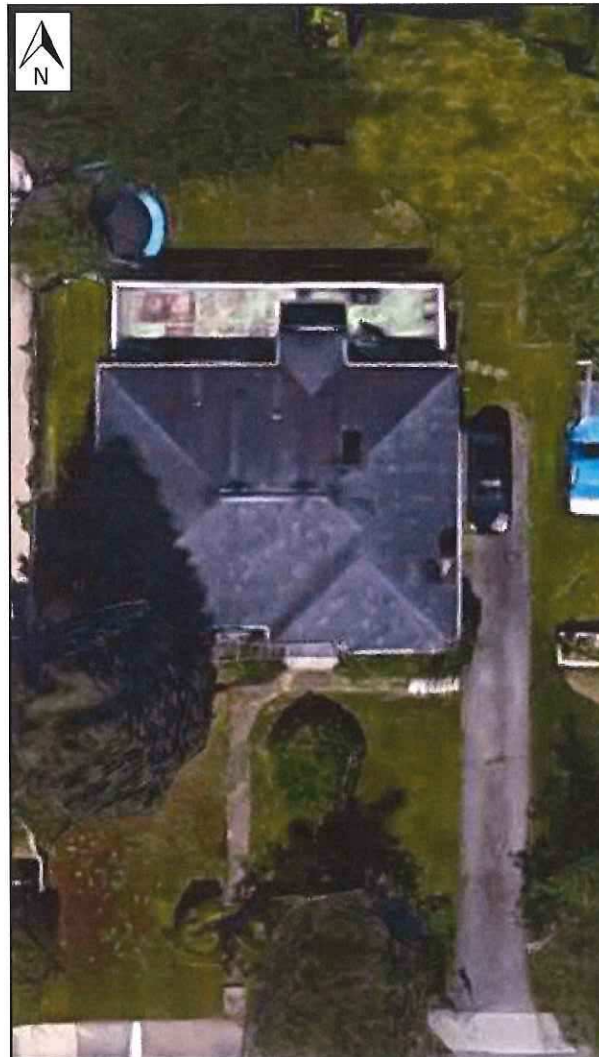
Conclusion: After examining the data collected from the survey area, it has been concluded that there are no anomalies characteristic of an Underground Oil Storage Tank present on the areas of the property surveyed (Image 1).

Image 1: Aerial view of property.
No inconclusive areas.
